# District 3 Sidewalk Study-Phase III

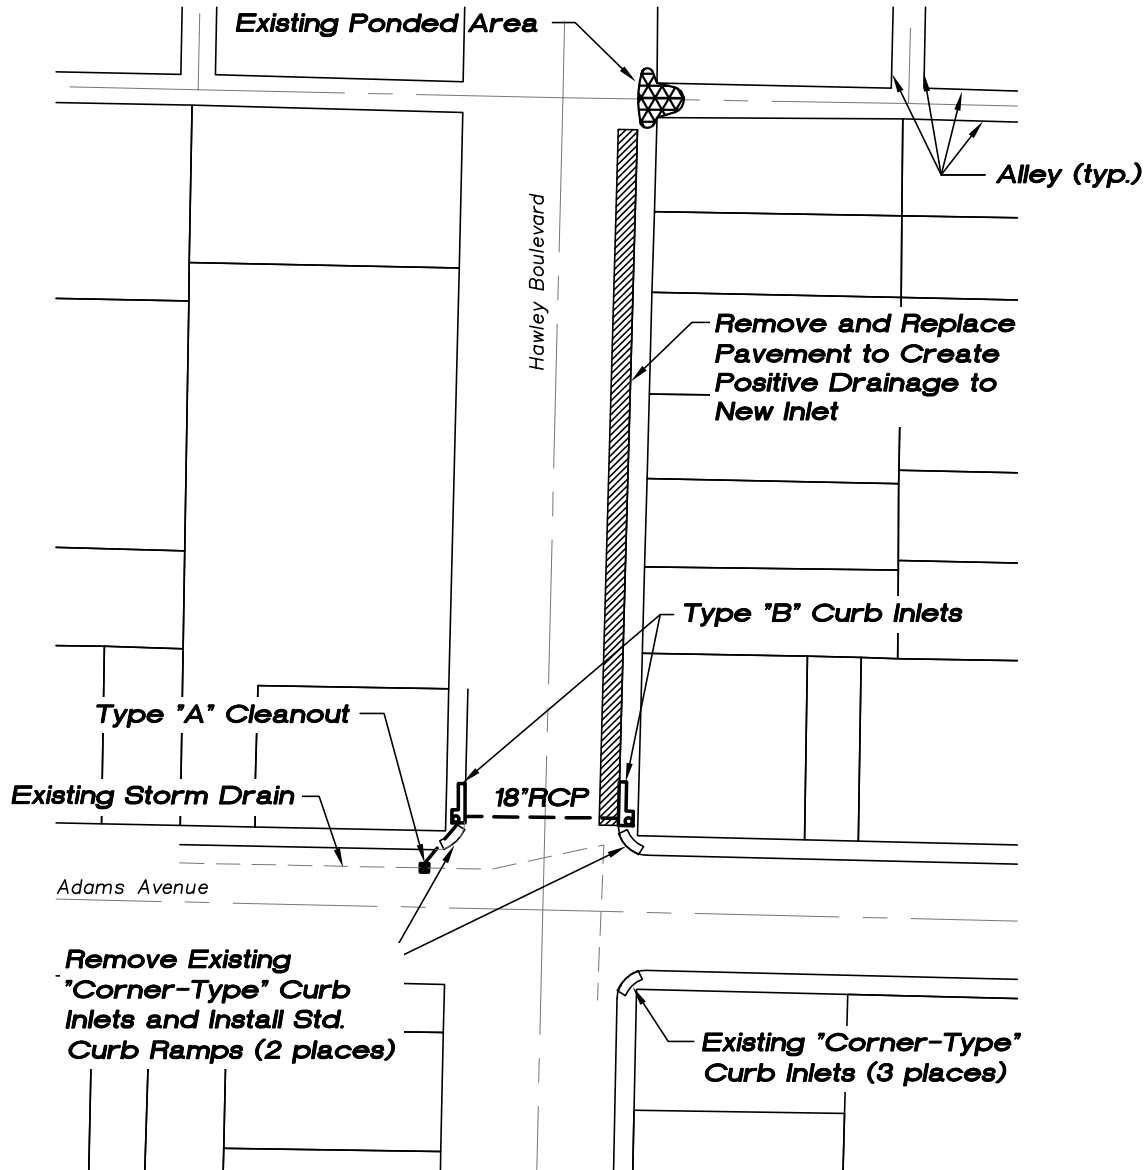
**Figure 8**

Existing curb heights are adequate on three of the four legs of this intersection, the exception being the north leg on Hawley Blvd., which has 3-5" curbs. However, further drainage improvements appear to be warranted here for the following reasons:

- All four segments are rated as "high" pedestrian demand
- Dry-weather ponding exists within the alley entrance on Hawley just north of Adams, which due to flat grades cannot be corrected by pavement grinding alone.
- Non-standard "corner-type" curb inlets exist on three of four corners (all but the southwest corner). Non-ADA-compliant curb ramps have been installed at each of these three corners.

Construction of new Type "B" curb inlets would permit installation of compliant curb ramps and safer crosswalks on all four legs of this heavily-used intersection. See **Figure 8, Adams Avenue Improvements**.

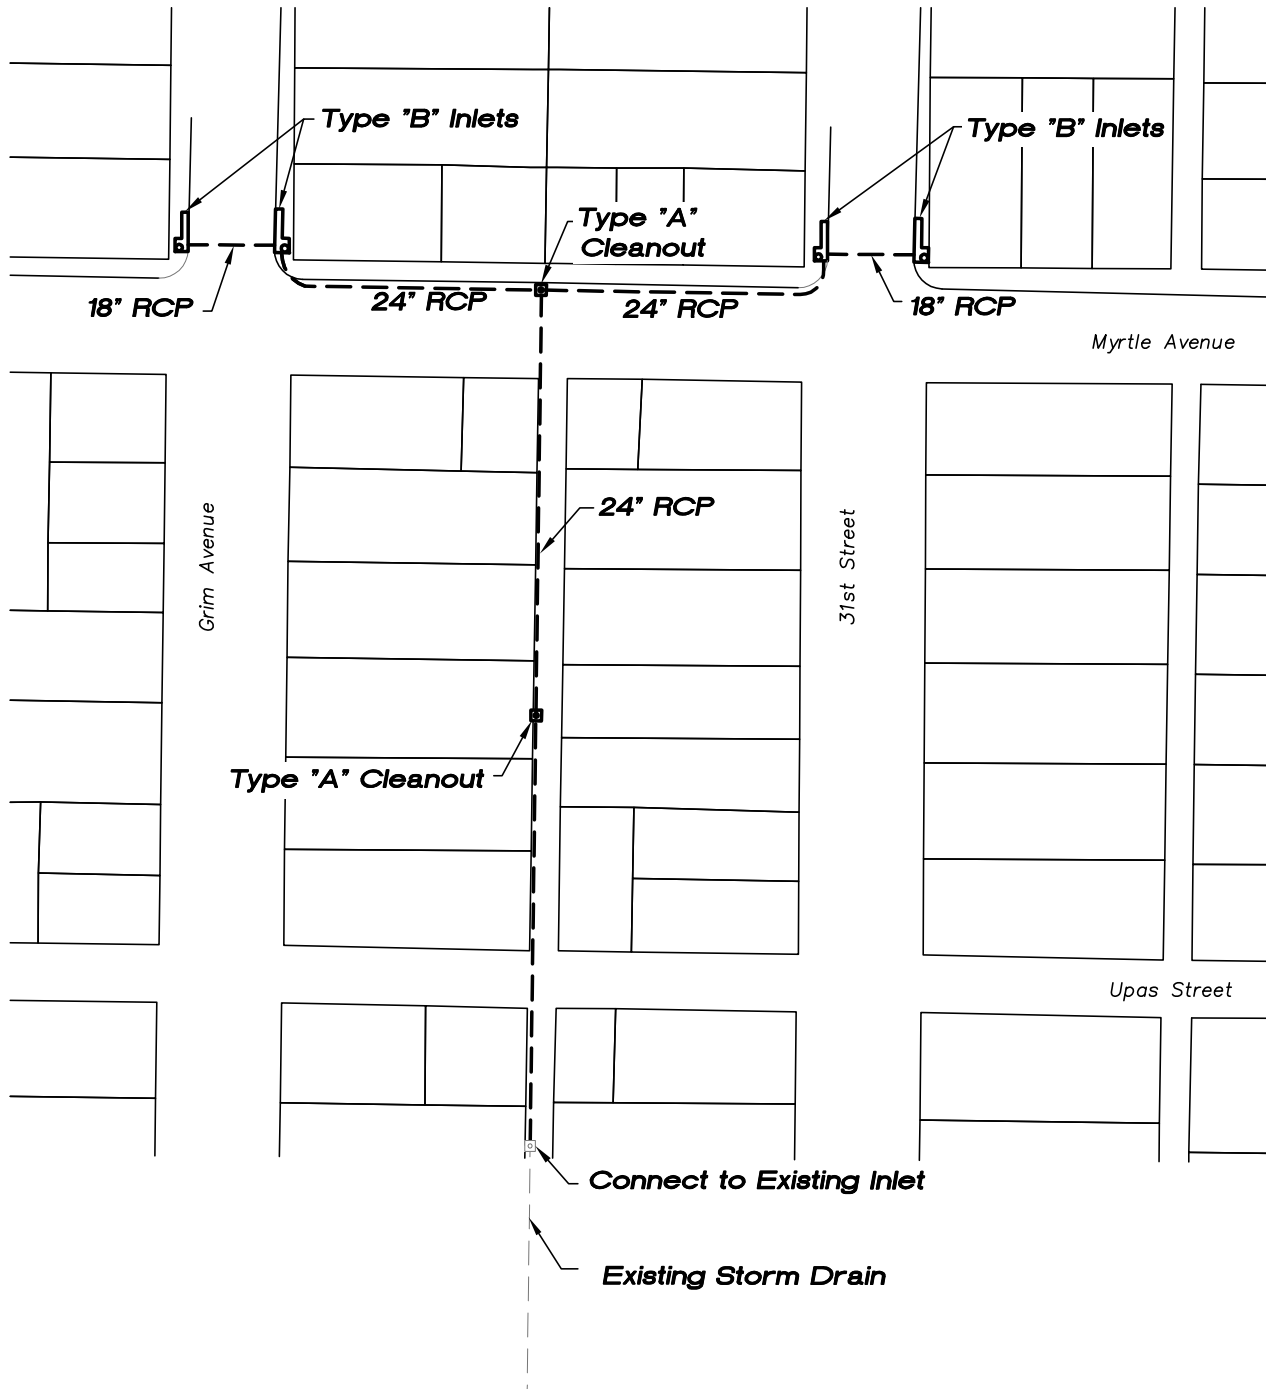
**Figure 9**

As shown on Fig. 2, the block of Myrtle Avenue between Grim Avenue and 31<sup>st</sup> Street receives runoff from two of large watersheds. The areas downstream of this point have been identified as having chronic drainage problems. This observation is reinforced by the runoff estimates shown in Table 5-3, which indicate that 31<sup>st</sup> Street has barely sufficient capacity for a one-year storm, and Grim Avenue has much too little capacity for even a one-year storm. A single underground culvert is proposed within the alleyway to capture and convey runoff from both of these streets to the existing downstream storm drain system, as shown on **Figure 9, Myrtle Avenue Drainage Improvement**. This improvement would provide benefits to several downstream blocks that are currently the subject of citizen complaints regarding drainage.

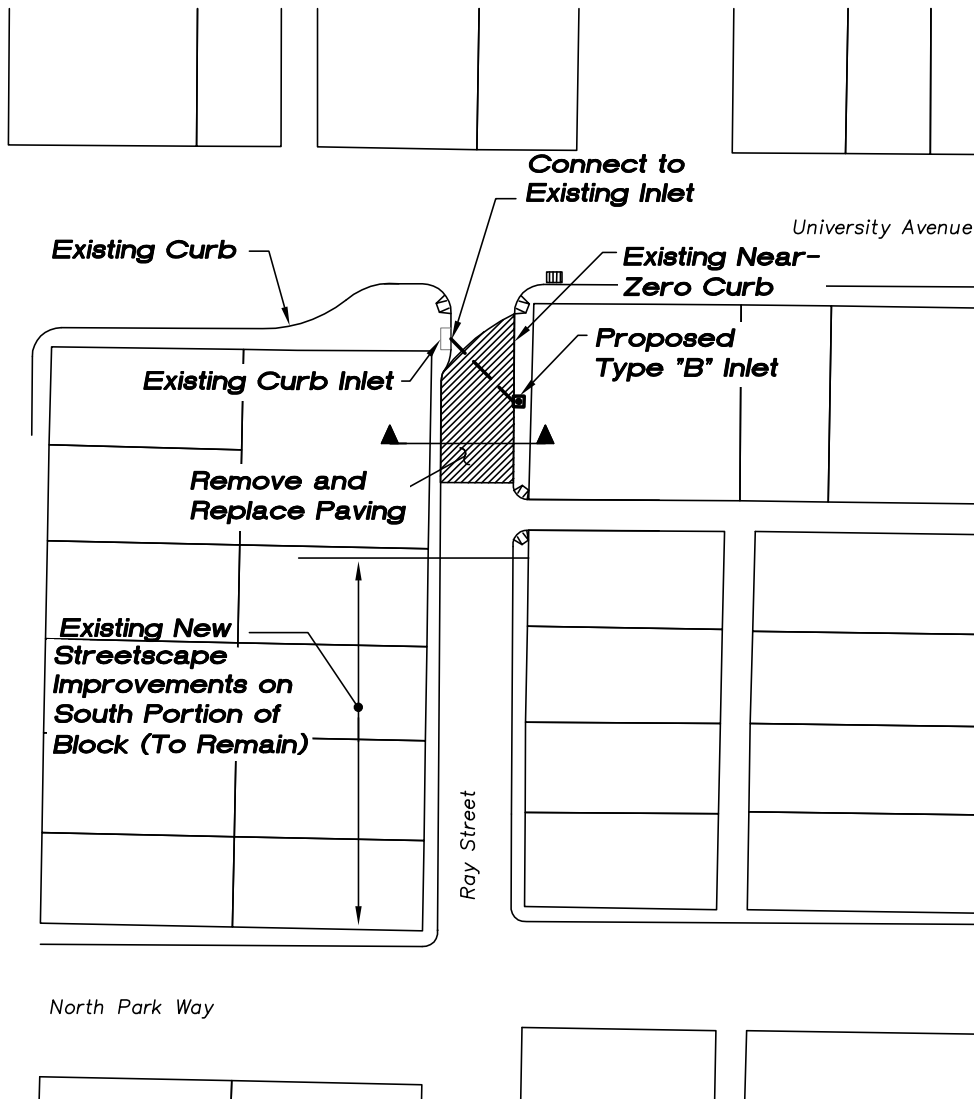
Figure 10

The northerly block of Ray Street, immediately south of University Avenue (segment NP77) has recently been extensively improved. The part of the block south of the alley entrances has mostly new streetscape and improved sidewalks. In addition, the streetscape along the adjacent portion of University Avenue has been extensively upgraded. However, the northern portion of the block remains in a substandard condition, with near-zero curb heights on the east side, and curb inlets that are not well positioned to capture the surface runoff. This area has recently become a significant venue for public events and experiences a high level of pedestrian traffic.

To close the gap in the upgraded streetscape here, and to provide for safe and proper sidewalk drainage, a small area of pavement replacement along with a new storm drain connection have been proposed. See **Figure 10, Ray Street Improvements**.
